Insight

Face Lift for Old Buildings

By Joseph W. Lstiburek, Ph.D., P.Eng., Fellow ASHRAE

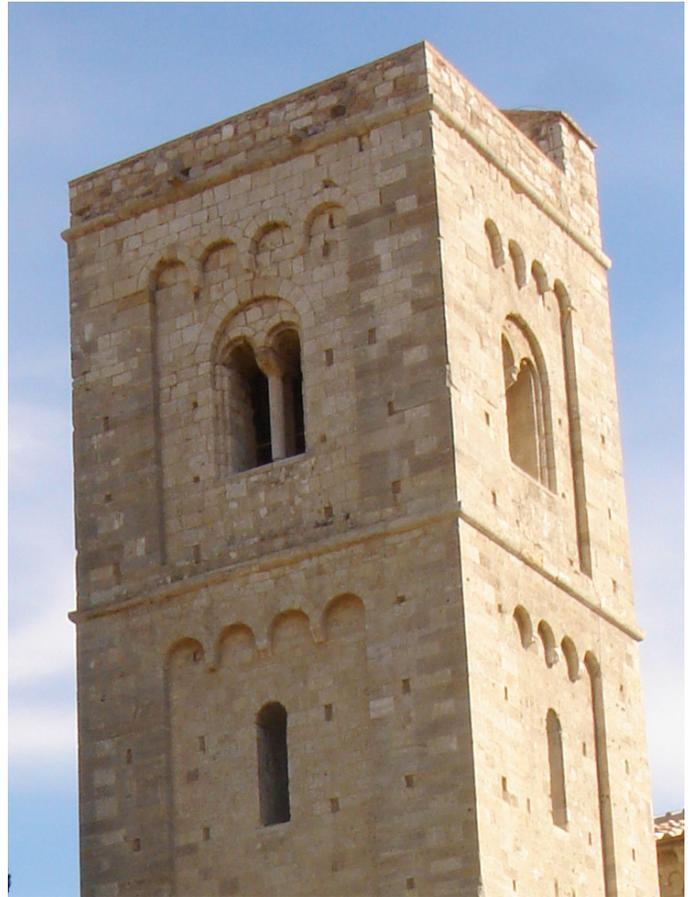
Photograph 1: Multi Layer Stone Wall—A stone wall many layers thick with each layer being constructed of carefully cut stones with nice tight joints with every joint off-set horizontally and vertically.

If you were rich like a King or a Pope you could have the entire wall built with nice carefully cut stones with nice tight joints. And if you were a real big dog King and a really rich Pope—and you weren't cheap—you could afford to have your wall many layers thick with each layer being constructed of nice carefully cut stones with nice tight joints with every joint off-set horizontally and vertically (**Photograph 1**). Alas, Kings and Popes often tended to be cheap. Building multi layer assemblies out of shaped rock with nice tight joints—well—that really "rocked." Too bad not much stuff was built that way. The stuff that was built that way lasted, and will last almost forever. "Forever," is a pretty nifty "useful service life."

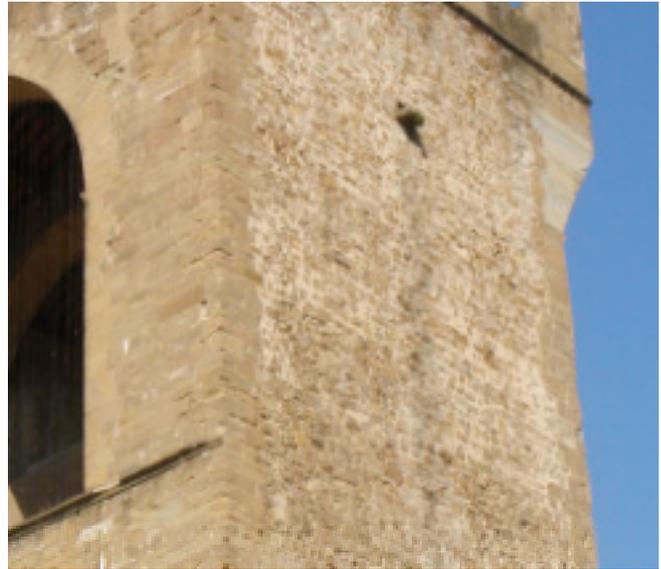
Photograph 2: Quoin Assemblies—Good stone corners and good stone lined “punched” openings with rubble comprising the “in-fill” of the wall.

Sometimes builders gave their clients a nice outer layer and a nice inner layer and threw a lot of stuff (i.e. “rubble”) in between. Even more often, clients only got good stone corners and good stone lined “punched” openings with rubble comprising the majority of the wall (**Photograph 2**).

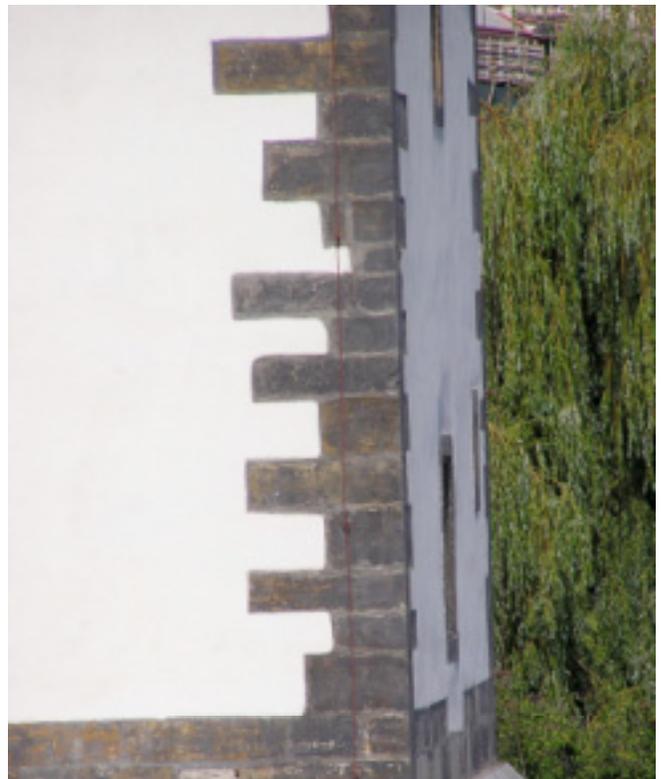
Photograph 3: “Traditional Stucco”—A protective layer of white stucco applied to a stone-rubble wall. The stucco was typically applied principally to the rubble “infill” between the quoins. Eventually even the quoins got stuccoed and the original function of the quoin was lost and quoins became aesthetic rather than functional.

Unfortunately these composite stone-rubble walls tended to leak and the leakage tended to make the wall look bad and then over time the wall tended to fall apart. When water gets into something bad things happen. This was very bad if the building was a castle. It was not a good thing to annoy a king. It became pretty common to stucco over castle walls so that the stucco protected the mortar in the joints in particular and the wall in general. The “White Tower” of the Tower of London got its name when Henry III had it stuccoed and whitewashed to keep the water out. “White Castle” in Wales got its name from the protective layer of white stucco applied to the stone-rubble walls. The stucco was typically applied principally to the rubble “infill” between the quoins (**Photograph 3**). Eventually even the quoins got stuccoed and the original function of the quoin was lost and quoins became aesthetic rather than functional.

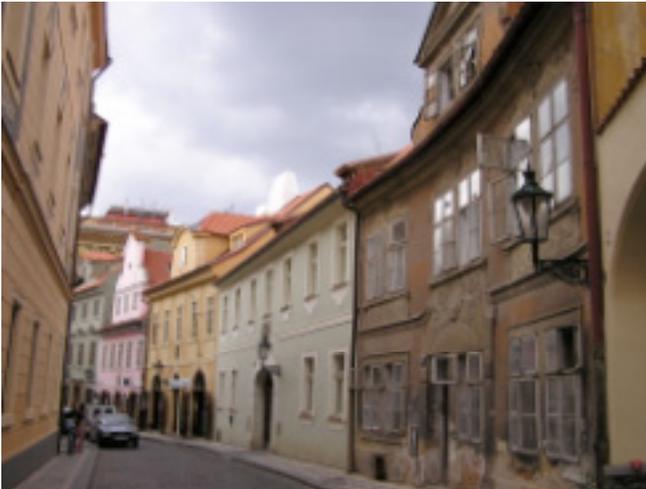
Photograph 4: “Got Stucco”—In Europe stucco has a wonderful reputation and is associated with addressing problem buildings experiencing rain leakage. Over time most of Europe got “stuccoed.”

From the middle ages onward stucco became the repair material of choice to address leaking walls and deteriorating walls regardless of whether the walls were stone, stone-rubble, stone-brick or all brick or combinations between. Over time almost all of Europe “got stuccoed” (**Photograph 4**).

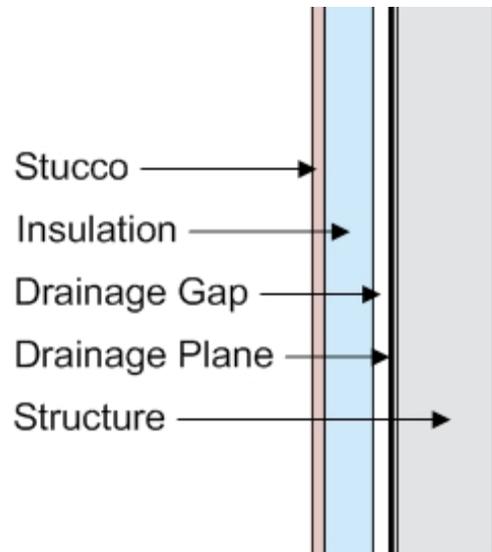
Figure 1: Insulating Drained Stucco—A stucco that is both drained and insulating—“wow, tastes great and is less filling.”

Of course Vitruvius had the answer, drain the stucco, drain the “EIFS.” In fact, drain all claddings. The EIFS industry figured it out and now offers “insulating stucco” that drains in North America (**Figure 1**). We are still working on “traditional hard coat stucco” systems installed in North America—they need to drain as well. Unfortunately, most “traditional hard coat stucco” systems installed in North America do not drain. Stucco should have a drainage gap behind it when it is used with water sensitive materials.

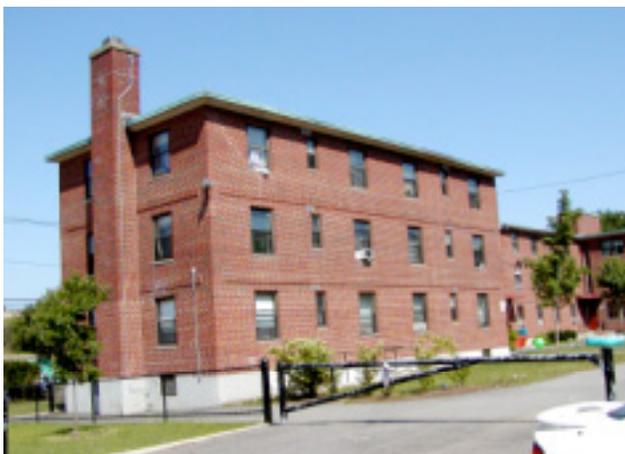
Photograph 5: Face Lift Needed—Uninsulated mass wall in Boston that is leaking rain, is cold, is uncomfortable, is an energy pig and is ugly to boot.

worse than the building in **Photograph 5**—an uninsulated mass wall in Boston that is leaking rain, is cold, is uncomfortable, is an energy pig and is ugly to boot. **Photograph 6** is what you can do if you have a great architect (Bruner Cott). Add overhangs, a pitched and vented roof, and a “stucco screen” that would make both Vitruvius and Henry III proud (**Figure 2**). Be prepared to see a resurgence of stucco “over cladding” in North America. The over cladding stuccos need to be drained. And drained and insulated is even better. EIFS is coming back, and coming back in a good way, and just in time because we have lots of old buildings that are going to need it if we are going to be serious about this climate change, green and energy security thing.

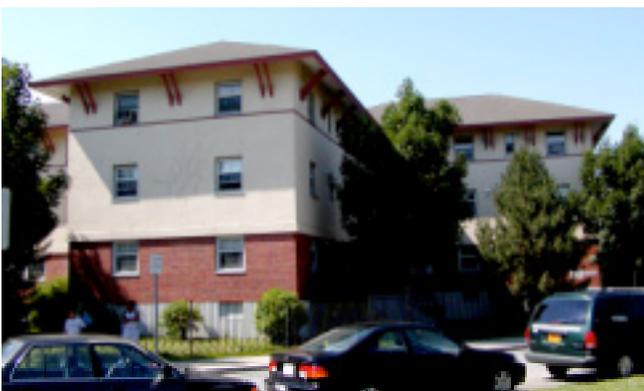
Photograph 6: Saving A Building—Add over hangs, a pitched and vented roof, and a “stucco screen.”

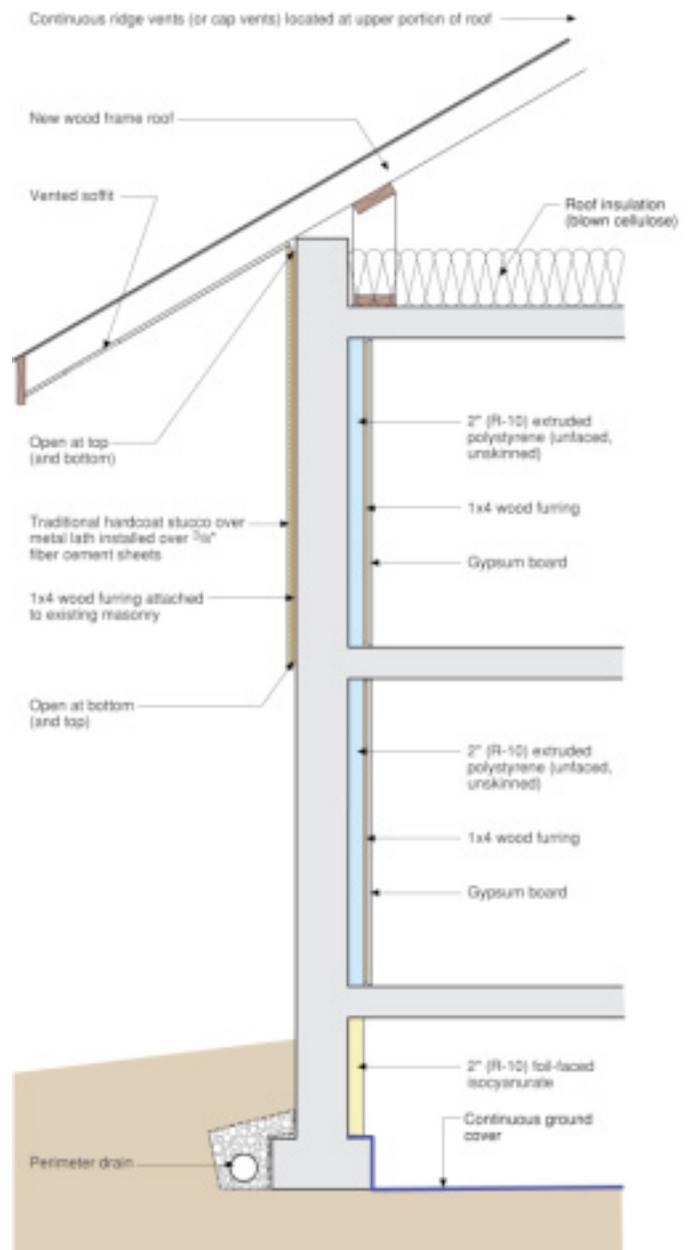
Figure 2: “Stucco Screen”—A drained and ventilated “stucco screen” is installed on the upper portion of the wall—the portion of the wall that gets damaged because that is the portion of the wall that sees the rain.
